CFR The Commercial Flooring Report

Volume 165 - June 2022

How About Some Wood Issues

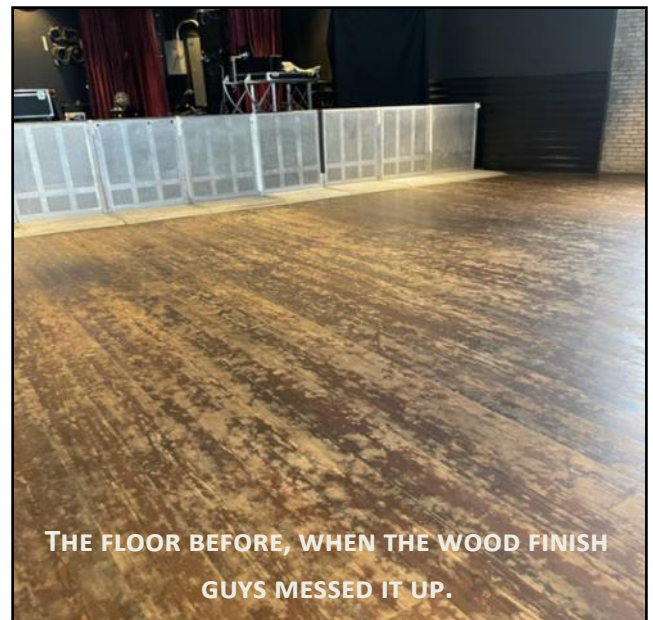
The first case we'll look at has to do with a dance floor in a historic building that is going to be used for weddings and other social functions. The wood being used for the dance floor is quarter sawn White Oak Rift. The finish being considered for application was a name brand polyurethane. The primary concern was for occupants slipping on the floor. To test the assembly with the proposed finish, we had the flooring contractor send us a 3x3 mock up of the wood flooring with the applied finish they wanted to use. The mock up was going to be tested for Coefficient of Friction, which simply put, is a test used to find out what happens when two items rub against each other to determine the moving and starting resistance of one surface that is being dragged across another. In this case, since the wood floor was going to be used as a dance floor, you don't want it to be so slippery that people slide all over risking a fall or have too much grab so they don't trip and fall when their feet don't slide. You must find the balance for the function of the wood dance floor. The finished sample we received looked and felt as slick as glass and it did not test well. There is no pass/fail for the test. It only renders how easily or not the test device moves across the surface. The finish used on the sample dance floor is extremely slick and not conducive to the safety of patrons who would be dancing on it.

THE FLOOR BEFORE, WHEN THE WOOD FINISH GUYS MESSED IT UP.

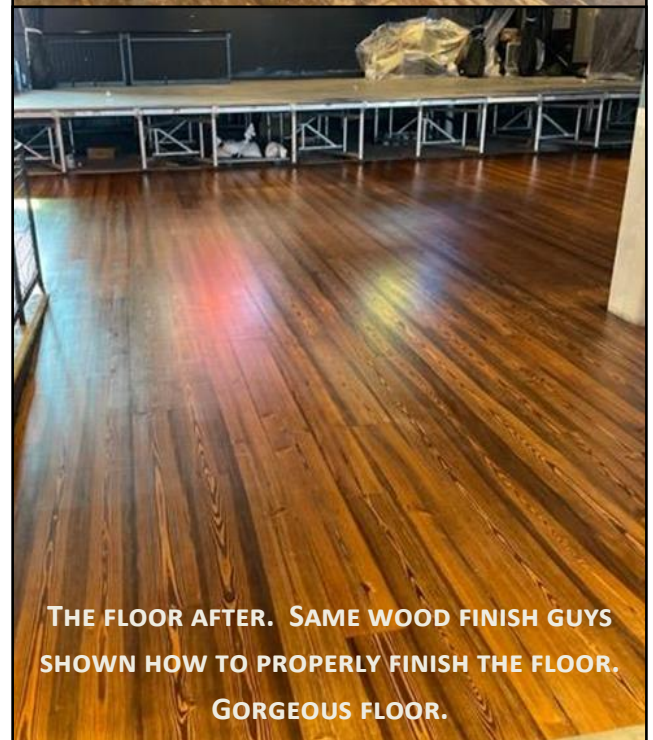
THE FLOOR AFTER. SAME WOOD FINISH GUYS SHOWN HOW TO PROPERLY FINISH THE FLOOR. GORGEOUS FLOOR.

The lab test results yielded an average Dynamic Coefficient of Friction of 0.28. This indicates a very slick surface that would be a hazard. A coefficient of .30 to .41 would be considered acceptable. A rating of .41 and up would be considered slip resistant. Though there is no published, specified, or official rating for a wood dance floor, our research revealed that a coefficient of friction of .33 should be an adequate dance floor surface rating. It is neither too slick nor too slip resistant. We did suggest two products that are used on dance floors that would work. So, now our client and the end user have an answer to their question, backed up by lab testing and followed with the research to get them a wood floor finish product that would work for this specific application. Easier than guessing or thinking something would work and going through all the effort to apply it only to find out it was the wrong product.

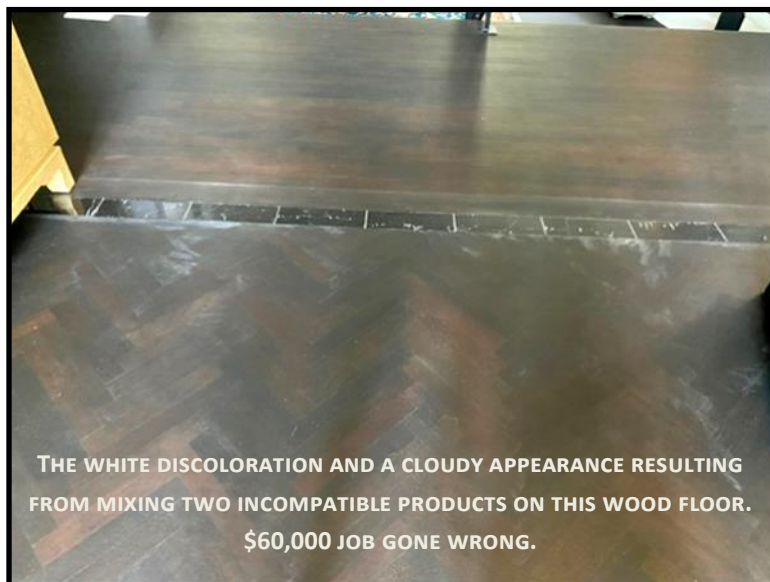
In another matter we had a consumer contact us with a wood flooring problem in her home. We normally don't do residential work, but we never turn anyone away that needs help with a flooring concern. This was a very large home where they had new wood flooring installed and site finished. There was a white discoloration and a cloudy appearance over the side and end joints of the dark finished wood. The flooring dealer came back to redo an area to correct the condition to no avail. Since this was a residential job, we referred it to one of the wood expert associates we use who focuses on this type of work. It was determined that the stain and the finish were incompatible. One was oil based and the other water based which caused a reaction between the two creating the surface appearance problem. The \$60,000.00 floor finish job had failed. Not a problem you want to have in your home, or anywhere else for that matter. This, no doubt, will result in a contestable issue where both the floor finish dealer and the home owner will be unhappy with the outcome. The question you have to ask is, why would they use two incompatible products? This condition can be corrected but it should never have occurred in the first place.

THE WHITE DISCOLORATION AND A CLOUDY APPEARANCE RESULTING FROM MIXING TWO INCOMPATIBLE PRODUCTS ON THIS WOOD FLOOR. \$60,000 JOB GONE WRONG.

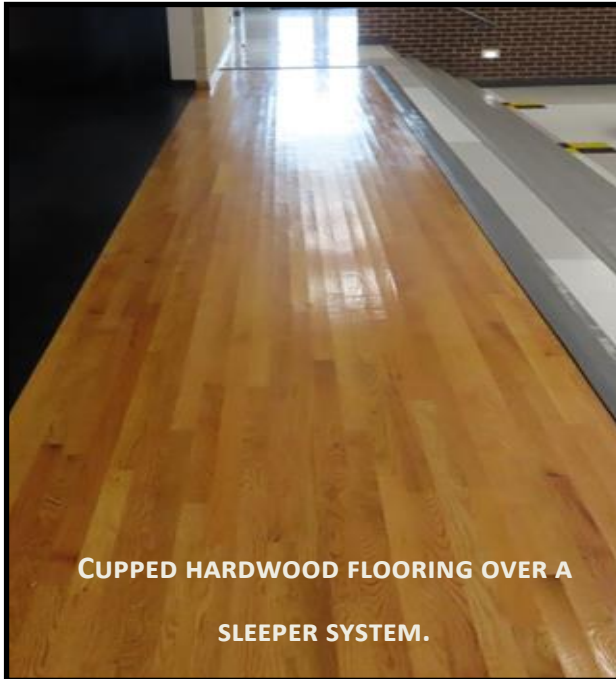
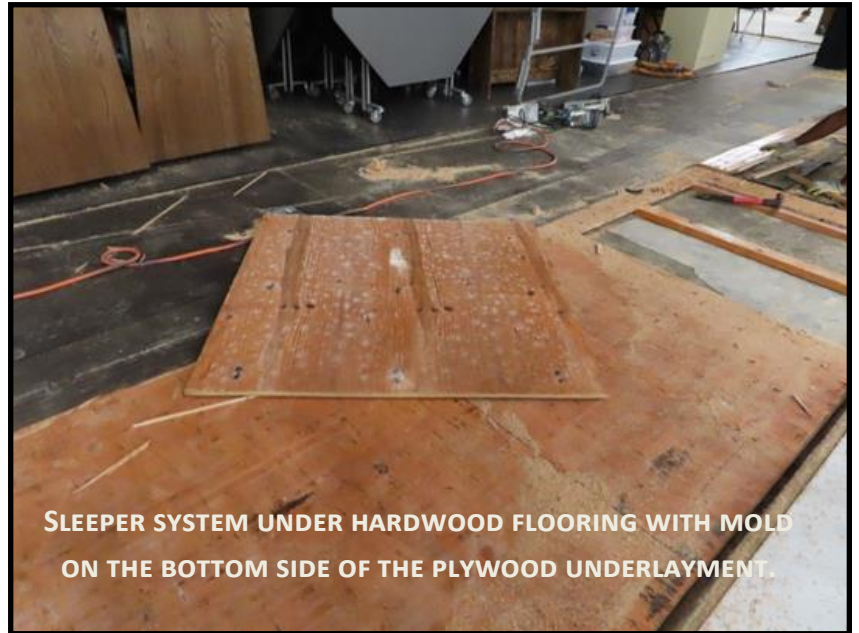
This next project was in a new school, where there was a failure of VCT due to moisture. We've been working with the General Contractor and the flooring contractor to remediate this issue successfully with some proprietary moisture mitigating technology. There was also a small amount of hardwood that was cupped from moisture, installed with a sleeper system, at the front of the stage area. Initially only the small section of hardwood was going to be removed to remediate the concrete substrate. Upon removal of the hardwood flooring, we found that the bottom of the plywood on which the hardwood was installed had mold on it. So, as it turned out, the entire stage floor had to be removed, the substrate on which the sleeper system was installed moisture mitigated and a new floor installed. This, again, was a hardwood flooring

installation that had tar paper installed below the sleeper system and space from that surface to the back of the plywood the hardwood was installed on. One would think that with that much supposed protection between the substrate and the hardwood that nothing would happen. Of course, no one anticipated there would be a moisture issue either, as is usually the case. Interestingly enough, the wood used on the stage, which was directly adjacent to the cupped hardwood, was not affected at all. Now, the substrate below the stage will be treated, and a new sleeper system installed, including new plywood and hardwood. In this case no one was complaining about the wood flooring, just the VCT, we saw the cupped wood on the first job site visit and there was no question it was being affected by moisture.
