Volume 72 • for the Commercial Floor Covering Industry • Totally Green Publication • August 2014

THE FLOOR COVERING ABATEMENT DILEMMA

THE COMMERCIAL FLOORING REPORT

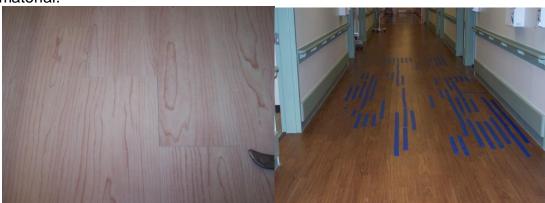
Shrunken LV Plank Over Abated Substrate

Cupped LV Plank Over Abated Substrate

What instigated the return to this subject was a call from a flooring contractor asking for help on a large project he's being asked to install thousands of feet of luxury vinyl plank tile. The previous installation of 9 x 9 asbestos tile flooring has been abated using a solvent/surfactant chemical agent. In addition the substrate, which is on grade and old, has high moisture vapor emission measured at 12 pounds and a relative humidity measured at 97%, basically the concrete slab is a soaking sponge. The moisture issue will exacerbate the solvent/surfactant issue and will prevent any flooring from being glued to the substrate with anything. The abatement chemical has housed itself in the matrix of the concrete never to be removed. The moisture in the slab will continue to migrate from it and in the process bring the solvent with it. The first thing to be affected will be the adhesive and subsequently the vinyl will be affected. The solvent will distort the vinyl flooring material causing it to curl, lift or otherwise change in form and possibly dimension. So not only will the installation not work but the flooring material itself will be adversely affected. The moisture will keep driving the abatement chemicals to the surface of the concrete where it will compromise anything on it. To say this is a catastrophe is an understatement.
