# CFR THE COMMERCIAL FLOORING REPORT

Volume 95 • August 2016 FOR THE COMMERCIAL FLOOR COVERING INDUSTRY • TOTALLY GREEN PUBLICATION

## YOU'VE DONE EVERYTHING RIGHT AND YOUR WRONG; NOW WHAT?

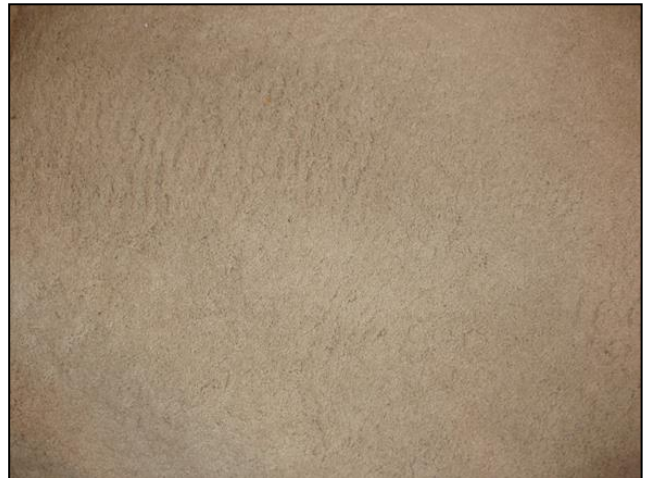
1. The first is the case of cornrowing carpet. This is a residential installation down for a short period of time that began manifesting corn rows – these actually look like rows of corn in a field thus the name. The dealer who happens to be a commercial flooring contractor with a residential division is being told the condition is the result of them using the wrong carpet cushion and installation. Now this is one of the most absurd and ludicrous reasons for denying a claim as I've heard in 45 years in the business, even though nothing surprises me anymore in this industry when it comes to opining on the cause of a flooring failure. The cushion under the carpet and installation has absolutely nothing to do with cornrowing. Now What? The cause is either manufacturing related – called gauge lines – which is a tufting issue or a vacuum cleaner set too low or traffic in a concentrated, unalterable and pivotal area but it is NEVER due to installation or the cushion. Long fiber lengths in high pile carpets are most susceptible to this condition such as shags and it rarely if ever plagues commercial type carpet constructions. This is why rakes are sold for this type of carpet so the pile can be “groomed” or lifted to remove corn rows.

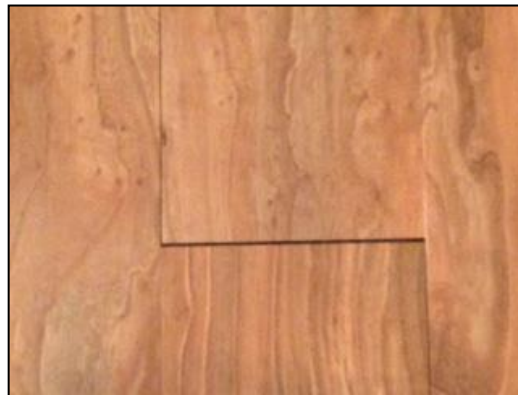
2. Ends' lifting on a luxury vinyl plank installation in a church is our next case. The installer says he did everything correct and he's installed miles of hard surface flooring and never experienced a problem like this. The LVP is only curling on the ends and all of the planks are involved. An independent inspector said this is an installation problem caused by using the wrong type of adhesive – dry set versus wet set. I can understand the reason for one versus the other in a commercial installation but neither method and no

adhesive is meant to hold modular flooring material of any type flat to the floor. The inherent characteristics of the flooring material to drape – lay flat and conform – should be built into the product. If the flooring lifts up on the ends or the sides this indicates an intrinsic characteristic caused by an imbalance in the material.

Now What? We can perform ASTM technical standards testing to determine whether a flooring product conforms to manufacturing and industry standards of which lying flat and being stable are a part of. You could also lay a couple pieces of the material on a perfectly flat surface – such as a glass top conference table (a revealing rudimentary test) in an acclimated environment to see if the materials edges or ends lift at all. We've found that sometimes when the ASTM tests are conducted there is no visible reaction until the material is allowed to relax for about 48 hours and then it lifts or curls. So we've learned to wait and see what the reaction is and then gauge it.

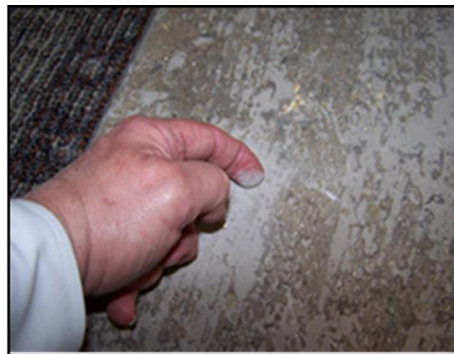
3. Substrates – concrete and wood – continue to cause flooring installation failures and this problem is not going to go away anytime soon. One case, of many on this particular issue, is adhesive degradation caused by alkalinity in the concrete substrate instigated by moisture vapor emission from the slab. Concrete, whether on grade or above, never dries and movement of moisture vapor from the concrete can be caused by changes in the ambient conditions in a building – primarily cycling of the air handling system or changes in environmental conditions caused by natural seasonal weather changes. The dealer used an adhesive that was supposed to be resistant to failure only to experience one after five years. Alkalinity from the concrete carried by the moisture vapor to the surface will break down the tackifier – the sticky part of the adhesive - causing the adhesive bond to disappear. Now What? After five years the flooring contractor has no recourse with the adhesive manufacturer or flooring manufacturer who mandated the use of the adhesive. The only thing to do which was being done is to remove the flooring material, scrape up the adhesive, mitigate the cause of the failure with a sealer and start over again.
