CFR The Commercial Flooring Report

WHAT'S IN THE MIX?

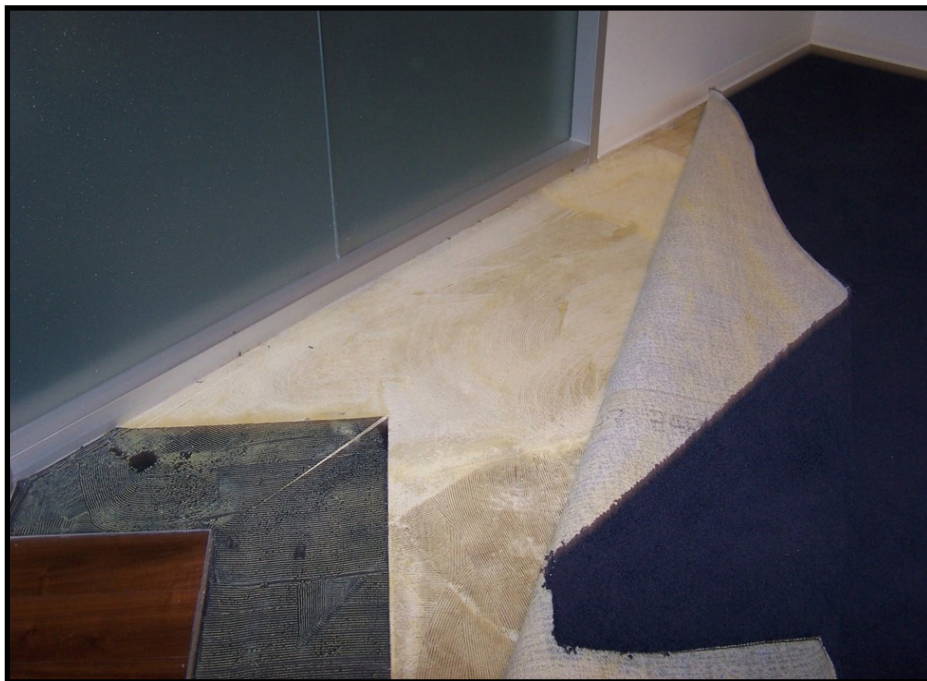
ALKALINE DESTRUCTION OF ADHESIVE

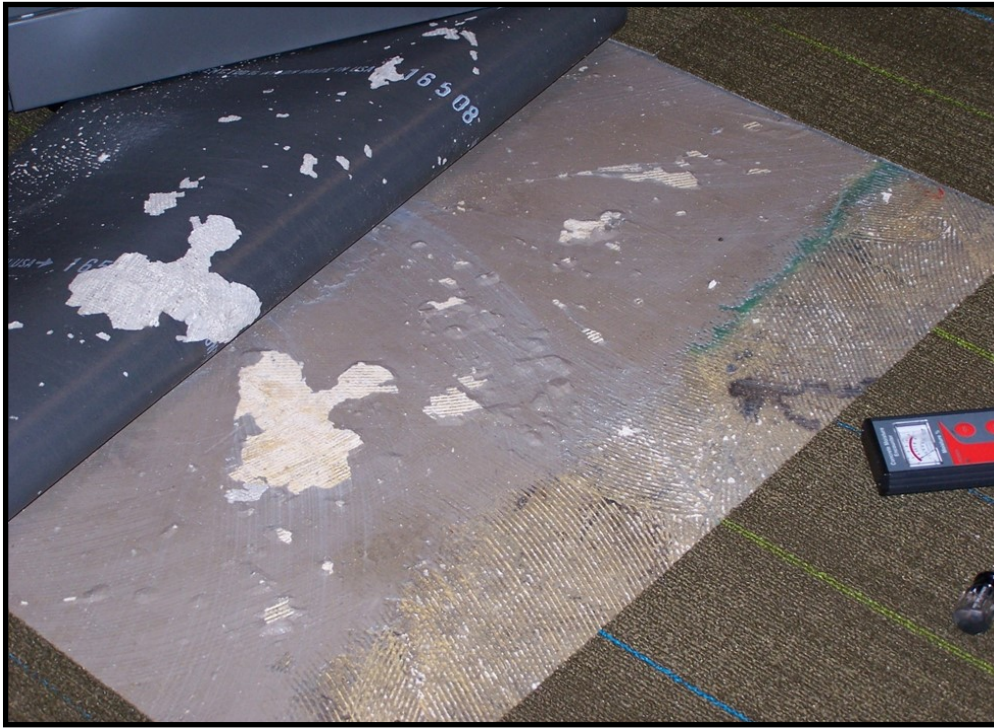
BLISTERING OF COATING ON CONCRETE SLAB

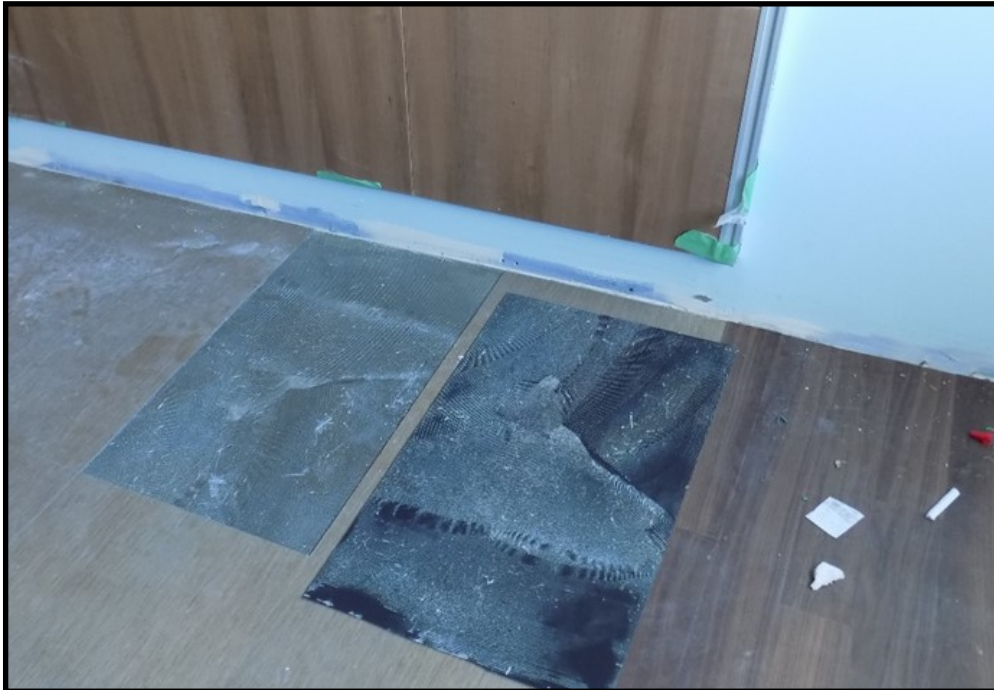
COMPROMISED BOND ON NEW SLAB FROM COMPONENT IN CONCRETE

In scaring you, let me share a recent project we were involved in. This is a brand new building, several stories high, where the flooring installed was exhibiting areas losing adhesion. When our concrete associates, who I consider some of the very best in the business, finished reviewing the concrete specifications, batch tickets, concrete mix design and all other pertinent materials, as well as analyzing the results of the core samples taken and tested, we found a component on the concrete surface that was acting as a bond-breaker and had compromised the installation. The independent testing agent for the General Contractor stated in their prior report that the bond-breaker on the surface was unremoved curing compound. Naturally the GC blamed the flooring subcontractor since flooring manufacturer guidelines all read "surface must be free of bond-breaking contaminants including curing compounds, etc." Through analytical testing we were able to confirm the material was not a curing compound, but was the super-plasticizer used as an admixture in the concrete. Prior to our involvement the flooring contractor was being blamed for a problem that wasn't his. This is the type of situation you guys may be finding yourselves in down the road with the changes on the way. Consequently, you're going to need to find someone that can help you steer clear of these mine fields, that knows and understands this stuff and knows what and how to look for it. I will tell you; this is very heady stuff and once our guys get into it, they start speaking a language they have to interpret for me.
