The Commercial Flooring Report For the Commercial Floor Covering Industry Volume 143 - August 2020 Click here to View and Download all CFR New sletters

THE EVIDENCE NEVER LIES

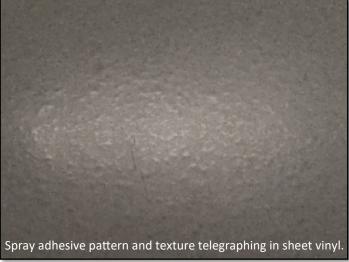
The first case we'll look at involves the installation of sheet vinyl flooring on several floors of a new building, with the complaint being texturing telegraphing through the face of the material. In this installation, a spray adhesive was used and the flooring subsequently buffed, not

waxed, increasing the sheen of the flooring. This resulted in the pattern of the spray adhesive being visible in the flooring. The manufacturer of the flooring material specified the spray adhesive. This condition was visible on every floor the material was installed on. When sections of the flooring were removed, the spray adhesive pattern matched the pattern on the face of the sheet vinyl. When the spray adhesive was tested by spraying several cans out of the same case on a sheet of plastic sectioned off, the spray pattern was visible. The pattern from different cans of the same adhesive varied, when it dried, the coloration of the adhesive was different and the volume of adhesive also varied. The adhesive was applied exactly as it is prescribed on the can. When spray adhesive is applied, it does not "squash" out or flatten out when rolled, so the pattern remains intact. In doing so, it can easily telegraph through the face of the flooring material. We've seen this in sheet goods as well as a project in which VCT was installed the same way, resulting in the same complaint. In this case the VCT was treated with several coats of a high gloss finish. This is not an installation problem that the flooring contractor should be blamed for. The installation was done as specified by the manufacturer. The problem is the use of spray adhesive that leaves a "popcorn" textured pattern on the substrate that will telegraph through the face of the flooring material, which is then exacerbated by buffing or putting a high gloss finish on the flooring. In both cases, we pulled up existing flooring material and re-installed it using different adhesives. For the sheet goods, we used four different adhesives. Two were spray adhesives, one was troweled on, and the other adhesive was rolled on. The rolled-on adhesive is what should have been specified and used for the installations, as it

leaves no pattern to show through the face of the flooring. If the flooring contractor is told how to install the flooring and what to use, and that process and component causes a complaint, the flooring contractor should not be blamed for following instructions.

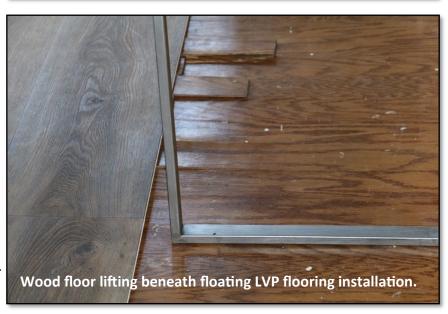
We hear it touted by those selling luxury vinyl plank flooring that you can install floating LVP over any type flooring and in some cases you can. In this situation, a floating LVP floor was installed over wood flooring that was installed on a slab on grade substrate in Florida. There was no moisture vapor retarder under the slab. After about eight months the new flooring began to separate, lift, and cup. The end user felt it was either a defect in the vinyl plank floor or an installation issue. A great deal of money was spent on testing for water leaks under the slab, arguing who was at fault and finger pointing. Most flooring

issues are not rocket science and if one understands what the flooring is saying, understands some physics and chemistry, the answer is often not as complicated as people want to make it. In this situation, the existing flooring was wood that was glued down on the concrete slab. While it existed on its own, it could withstand the influences of the slab. When the LVP was installed, the LVP became a moisture vapor retarder on top of the slab and the existing wood flooring. Since vinyl is not permeable, the moisture was trapped, and what happens to wood flooring when it is influenced by moisture?

It reacts. In this case swelled, expanded, and lifted up, lifting the new flooring installed over it. This was a case of ignorance by the people who sold and installed the LVP not understanding the consequences of installing the new flooring over the existing wood over slab on grade concrete. This was an accident waiting to happen. The result was the failure of both flooring materials that had to be removed and the installation started over. After taking up the flooring, there are several ways that a successful installation could be accomplished.
