CFR The Commercial Flooring Report

Volume 151 - April 2021 [Click here to View and Download all CFR Newsletters](#)

YOU CAN'T BE SERIOUS, AGAIN!!!

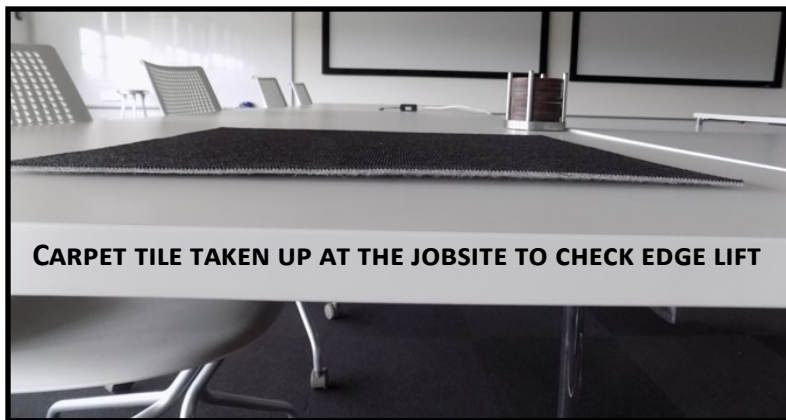
The installation of a graphic tufted carpet product, glued directly to the substrate. Graphics tufting involves two needle bars on the tufting machine that operate in opposing directions as they shift back and forth tufting yarn into the primary backing. This results in a construction where the shifting yarns step over one another (also referred to as step over stitch) creating a construction that one could loosely compare to a chain link fence, but much more tightly constructed. Installing these products has been a challenge for as long as they've existed. Years ago, installers would glue these products to the substrate only to come back the next day and find the seams shrunk a quarter of an inch. The yarn would absorb moisture from the adhesive, expand and, like the chain link fence, pull everything together, in other words, pull the carpet in at the width. The fix for this was to nail the carpet at the seams to hold them in place and clamp them as well. Also, an extremely aggressive adhesive should be used. The adhesive should be applied to the substrate with the appropriate trowel. Next, put the carpet into the adhesive while its wet, making full contact with the carpet backing. Next, pull the carpet back and out of the adhesive – this allows for adhesive application to both the carpet backing and the substrate. Next, let the adhesive start to tack up on both surfaces and put it back down and roll it. This is called the contact method of installation. And don't forget to use seam sealer. When we had someone call and tell us they had this problem and send photos and explain what was going on, it revealed a classic example of what this type of carpet construction does. The carpet base, adhered to the wall, was made of the same

product, cut in strips from the length of the carpet and bound on one edge and glued to the wall. This piece of carpet also shrunk leaving a gap at its base. When he explained this to a “claims expert” he was told this was impossible as carpet does not shrink up. Now think about that. The carpet base is constructed from strips cut from the length of the material. Whether it was installed at the base of the wall, on the ceiling or diagonally on the wall, it would shrink; the same as the carpet on the floor. The ignorance of the statement that “carpet does not shrink up” is astounding. But this is the type of “enlightenment” you have in the industry today when it comes to handling claims.

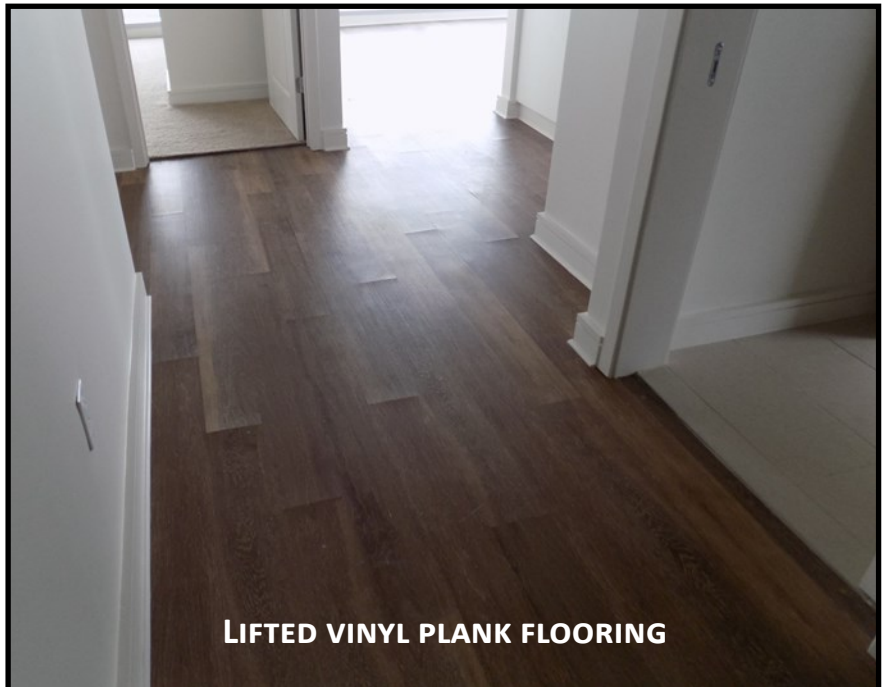
Let's look at another case. This one involves a plank flooring installation in which random planks are lifting. The manufacturer's position is that the material is not properly installed, that environmental conditions are causing the problem and that the space is not conditioned properly.

When the physical inspection took place, the condition exhibited and seen with wood patterned vinyl plank flooring was that it was lifting in various areas in each of the units it was installed in. The first thought was, naturally, that the cause was installation. At a meeting of all parties the supplier of the vinyl plank flooring said that the material could not be used in direct sunlight and that the temperature of the space had to be between 65 and 85

degrees F, as well as the temperature of the concrete substrate. The fact that the use of the product was so restrictive, and the parameters in which they were stating that it could perform in were so limited, would send up a red flag that this product should not be used – not only here but anywhere. Second, getting the substrate to meet the same temperature requirements of the ambient space is beyond ridiculous – that is never going to happen. Another stupid comment that deserves a slap in the back of the head. This also brings up the legal issue of the product not being merchantable for service or fit for the intended purpose of use as a flooring material.

The physical inspection, analysis, evaluation, research and investigation and testing determined that the product was reacting to normal conditions and most detrimental was the reaction to the underlayment it was installed over. The vinyl planks are made with recycled content and glued down to crumb rubber underlayment – made from recycled tires. These two materials have inherent incompatibilities

and putting them together is not condoned by many vinyl flooring manufacturers. This is a topic we've covered in a separate issue and mentioned several times. Vinyl flooring materials should never be installed over crumb rubber underlayment – PVC (vinyl) and SBR (rubber) should never come in contact with one another.

The big issue in this case starts with the designer and the architect and the desire to be green and qualify for LEED points on this project. Both the flooring and the underlayment are made with recycled content. I'm all for recycling and being green and shudder if I see a paper blowing around but, in this case, there needed to be some research done. As it turns out the underlayment instigated the flooring failure. The installation of the flooring had nothing to do with why there was a problem. The flooring itself, by admission of the supplier, is affected by normal conditions all types of flooring exist in every day. They also stated that this material is inexpensive and has a limited life span of 3 to 5 years. Did they give anyone this information when they were hot for the sale? Do they expect that this is going to be music to the ears of those looking at a multi-million dollar building that can't be occupied because the flooring is failing? And do they think that saying you can't use this material as you would expect to use any flooring because the sun affects it is going to make anyone happy?

In this situation you have two issues. First, the underlayment which is actually instigating the visible physical change in the vinyl plank flooring and second, the effects of nature on the material exacerbating the condition. So now everything has to go into the landfill which eliminates any green advantages. A different, more expensive and stable vinyl plank product has to be installed, the existing floor and underlayment trashed, more expense in labor to rip up and re-install and expediting all of this work so occupancy generating revenue can take place. After this comes the fun part of this situation going legal. The trail of what went wrong and why and who is at fault became clear. In this case a lot of parties have culpability and the one party with none is the flooring contractor, he and the installers did nothing wrong.
