The Commercial Flooring Report For the Commercial Floor Covering Industry Volume 183 - December 2023 Click here to View and Download all CFR New sletters

It's Not Always the Concrete Substrate that Causes a Failure

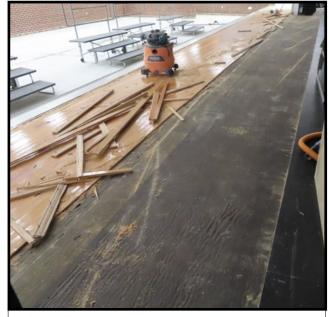
THE WOOD IS CUPPED FROM MOISTURE. IT IS INSTALLED OVER
A SLEEPER SYSTEM THAT HAS TAR PAPER, USED AS A MOISTURE BARRIER, ON TOP OF PLYWOOD
