# CFR The Commercial Flooring Report

Volume 186 - March 2024

## Fixing Moisture Related Flooring Failures and Some More Absurd Statements

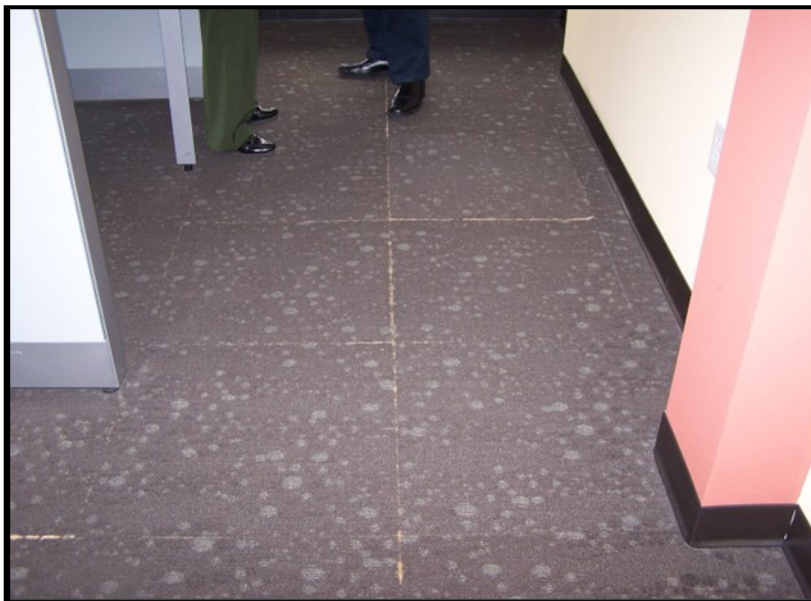
Moisture caused flooring failure. So much moisture that the adhesive is oozing out between the edges of the carpet tiles like lava from a volcano. This is the job mentioned that we developed a fix for.

So, getting back to answering the question of what can you use to fix the failure that will work once any other influencer is corrected. We worked with HB Fuller to develop a unique product that would prevent the reoccurrence of a moisture failure. It took a while to develop and is a hybrid of an already existing moisture mitigating technology. It had to be effective, easy to apply and work with, and fairly priced. That product is **System 2 MVB (Moisture Vapor Barrier)** and it was developed solely as a fix for moisture related failures. This product is not available on the open market or from HB Fuller. It was not meant to compete with any other products on the market as it is to be used for a very specific niche. To date, there has never been a failure of the system and the substrates it's been used on that you could almost do the back stroke on – they were water wet. If you're interested in knowing more about this product and where you can get it, (not from HB Fuller), contact us (LGM) and we'll get you in touch with the supplier, and the supplier is not LGM. By the way, this system has a real warranty, and a technical representative can be on site to show your crews how to use it.
