# **Complicated Cork Floor**

This article is by Steve Tolli an LGM Associate based in New York, and for eight years served as the technical director for North America for the world's largest cork flooring manufacturer.

Earlier this year I was asked to look at a cork floor and give my opinion on what could be done to fix it. The floor was at the Addleston Library on the College of Charleston campus; the request

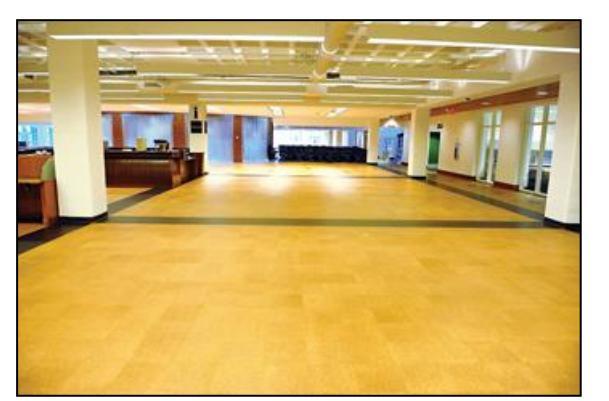
The college staff were in a bind: They were anxious and perplexed about having a fairly new high-profile library with a floor that already looked worn, damaged and faded, and they had conflicting opinions from multiple contractors and other individuals in the flooring industry regarding what to do. Should they replace the entire floor or resand it? If it needed to be resanded, how should it be done? During my inspection, I focused on the first level, which was the major concern due to its being the main entrance. I could see that in addition to the other complaints, the substrate hadn't been brought to within industry requirements; there were differences in height of ½ inch in 6 feet and as much as 1½ inches in 30 feet.

There was also the issue of covered channels under the floor where electrical wiring ran for the numerous computer stations.

When my inspection was completed, I concluded the cork flooring could be resanded and refinished after certain repairs were completed, such as replacing worn, loose and damaged tiles. I explained that the undulations within the substrate, which were highly visible telegraphing through the tiles, wouldn't go away, since the subfloor had not been flattened. On a positive note, I explained that, after sanding, the natural and dark tiles would return to their original colors (the color on the dark tiles goes through the thickness of the material due to heating during manufacturing) and would be protected by a urethane coating. In order to make the college more comfortable about my decision, I resanded and coated a small test area so they could see exactly what the cork would look like.

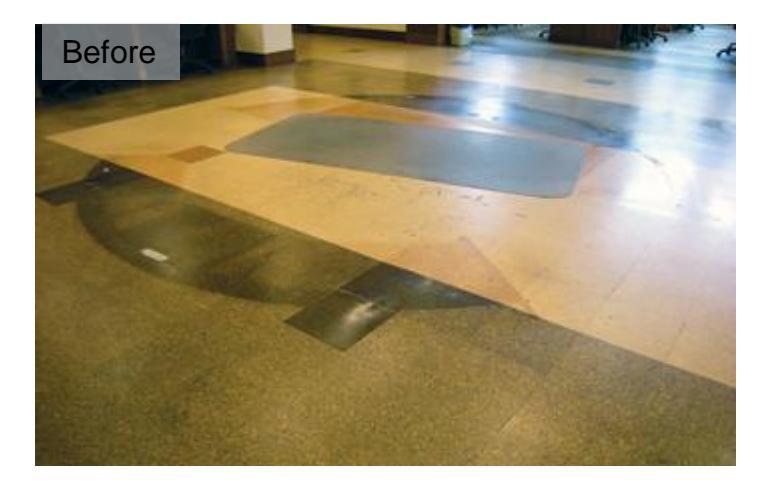
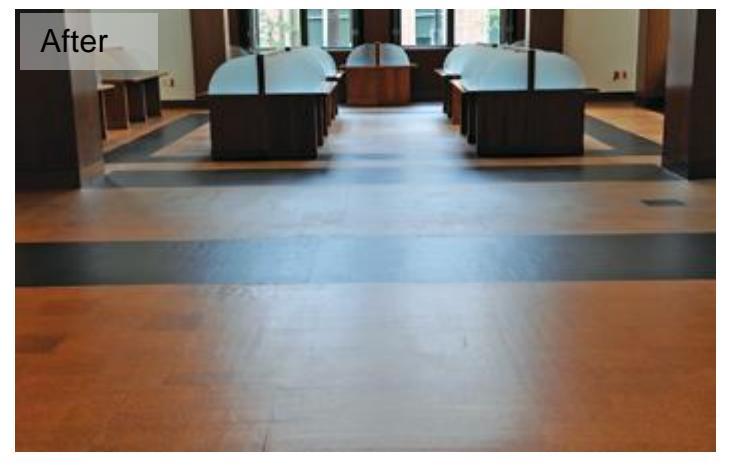
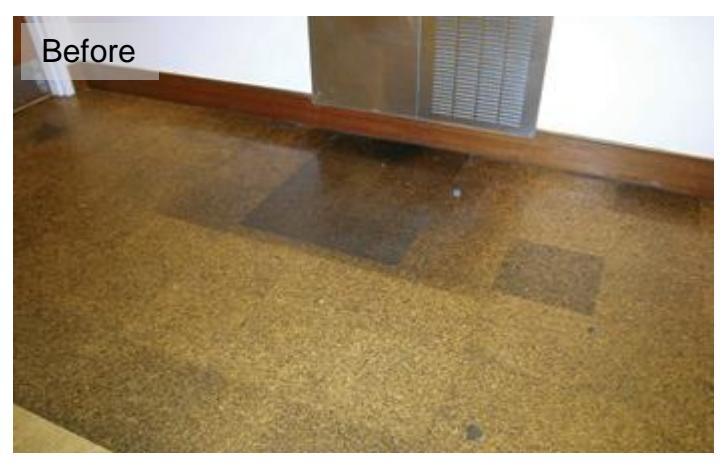
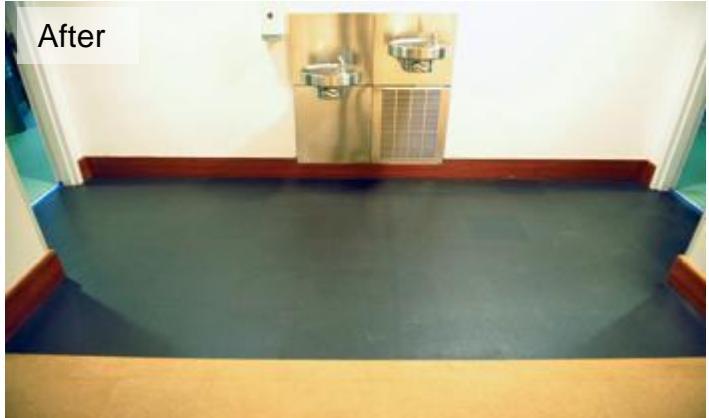
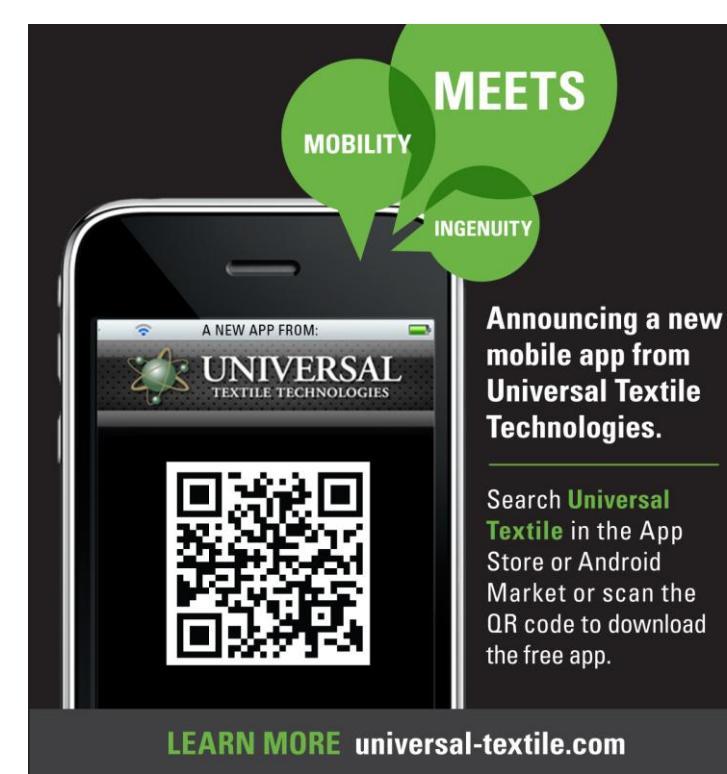
Looking back, the biggest obstacles on this job were definitely the undulations in the substratetrying to work with its uneven subfloor without removing excess cork material-as well as having to hand-sand around the computer desks and manage sanding over the deflecting channels. Of course, you can still see many undulations but now the tiles are restored to their original colors, all surface debris is removed, and the cork floor is completely refurbished, with the approval of the entire college staff involved in the process. The new finish is wearing extremely well and is maintained within the outlined spec, and the appearance of the library isn't an embarrassment to the college anymore. The college was also extremely pleased that the contractor could provide the college with enough manpower to complete the job within a tight timeframe while surpassing expectations for the floor's overall appearance.

It does take experience working with cork, as with any other flooring material, but it is not that difficult if you are trained properly and taught how to overcome any obstacles. This particular job was very difficult—some people had predicted it couldn't be corrected in this manner—but with the expertise of the crews using the specified guidelines, it turned out beautifully.
