# CFR The Commercial Flooring Report

Volume 172 - January 2023

## What's In The Mix, Again?

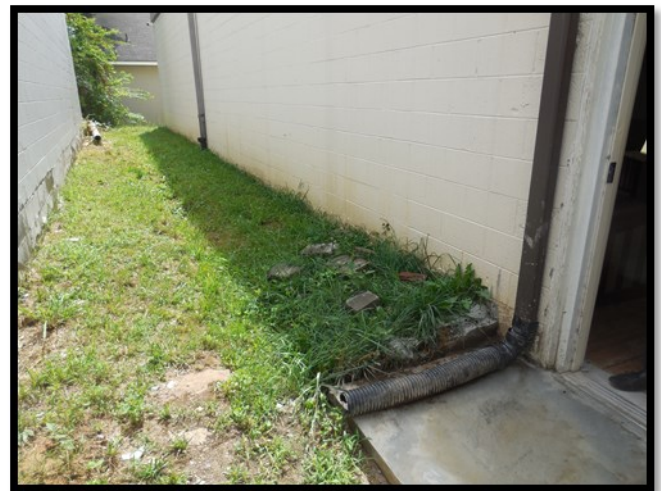
**ALWAYS LOOK OUTSIDE**  
PART OF THE SLAB IS ON GRADE AND PART BELOW DUE TO THE GRADING OF THE BUILDING

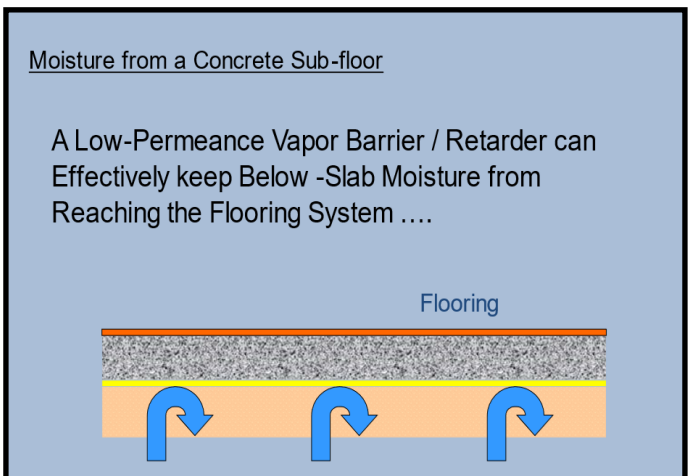
**THIS DIAGRAM SHOWS WHERE THE MOISTURE VAPOR BARRIER/RETARDER MUST BE PLACED, DIRECTLY UNDER THE CONCRETE, TO BE EFFECTIVE.**
